Royal Slope Railroad Inspection

April 2015

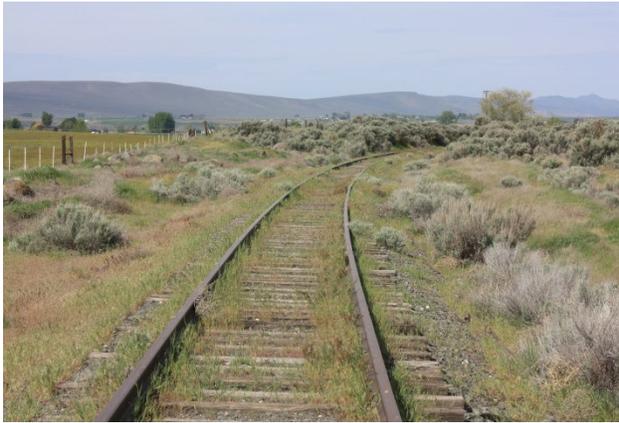
Figure 1 MP 1989.6 Vicinity

On April 23, 2015, WSDOT Staff, accompanied by Port Commissioners Alan Schrom and Davey Miller, conducted an inspection of the Royal Slope railroad. The port provided a speeder car to perform the line inspection. The inspection began at the crossing of the East Pothole Canal and proceeded west. The greatest immediate needs on the line are vegetation control and drainage maintenance. Figure 1 below shows the results of not implementing a regular vegetation maintenance program. Another issue pointed out in the Final Inspection Report is the right of way encroachments in the section between MP 1990.6 and MP 1991.1. This can be addressed through communication with the landowners, the installation of No Trespassing Signs or the most expensive option of installing fencing. Figure 2 below shows typical drainage and vegetation issues encountered on the first miles of the line. Vegetation control and drainage maintenance has not been performed. While not severe yet, continued negligence of these activities will lead to further degradation of the line and increased costs in the future to bring the line in to operation.

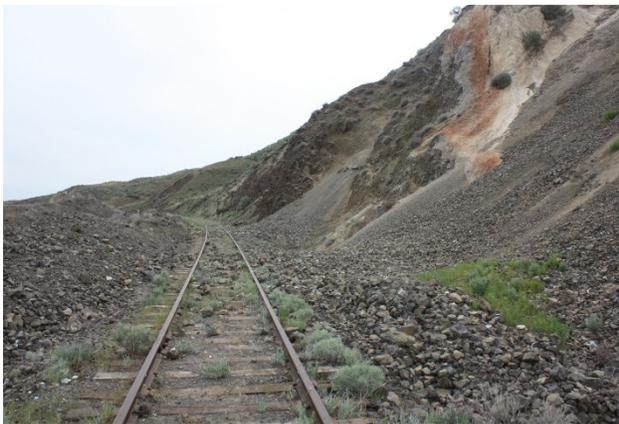
Figure 3 MP 1999.5 Vicinity

Additional work to return the line to service will be to address rock slides in the vicinity of 1999.5 as shown in Figure 3 above. This section appears to be prone to periodic slides, so that ditching and clearing the tracks of rocks will likely be a continuous type of maintenance activity for the approx. 1 mile of track along this cut. Figure 4 above shows another section of the line where ditching and drainage maintenance will be required. The immediate need is to perform vegetation control reestablish the ditches and ensure proper drainage away from the track. Longer term issues here involve finding and cleaning existing drainage structures or installing additional drainage structures. Also an examination of removing the earth berm on the north side of the tracks should be undertaken to determine if this provides an improvement in the track drainage. Other washouts creating conditions similar to that in Figure 4 exist at MP 2009 and 2009.5 vicinity.
